MARINE INVESTIGATION REPORT

M03L0026

GROUNDING

THE BULK CARRIER *GREAT CENTURY*
OFF BATISCAN, ST. LAWRENCE RIVER, QUEBEC

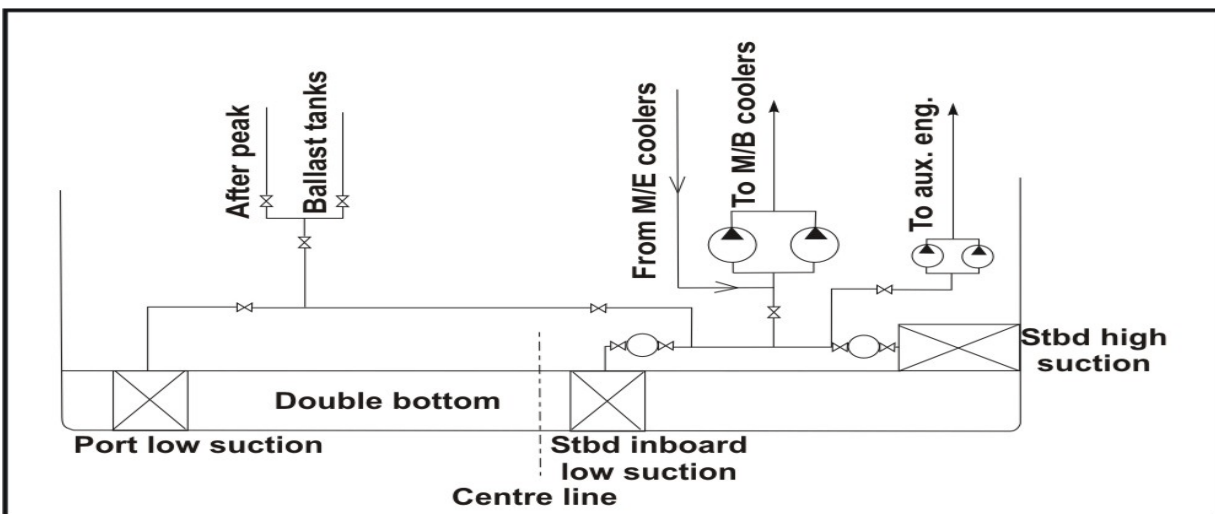
The vessel had three sea chests that were vented and each was fitted with a flanged vent valve on top. However, there was no permanent steam or air line connected to them. The two sea chests on the starboard side were used as a sea-water inlet to cool the main engine and generators (see Figure 2). The high sea suction inlet was located on the ship's side, while the low suction was found on the ship's bottom in way of the centre line. Both are fitted with strainers and isolating valves and linked to a common pipe. The third sea chest is located on the port side and is used mainly for the ballast operations. The circuit allowed interconnection between the three suction.

The cooling system of the main engine is separate from the generators. To protect the generators from overheating, built-in protection devices would automatically shut down the engines. The vessel was not designed to re-circulate the cooling sea water for the main engine and generators when navigating in ice-infested waters. However, a connection is available between the aft peak, ballast tanks and No. 4 cargo hold and the suction side of the main sea-water cooling system, but it was not considered as a recirculating internal cooling system. It is only usable as long as there is water in the tank from which water is being drawn, or as long as the tank can be refilled. In the vessel's ballasted condition at the time of the occurrence, these tanks contained a total of 24 247 metric tons of ballast water available for emergency cooling of the main engine and generators.

Figure 2. Sketch of cooling water arrangement of the *Great Century*

Given the cooling problems, they concluded that it was defective and by readjusting it, assumed that the recirculation system had been re-activated. A change from low to high sea suction was carried out in Bécancour. This runs contrary to the accepted practice to use the lower suction, which is less likely to be affected by loose ice. This situation continued until the vessel had departed Bécancour, when the crew finally recognized that the sea suctions were becoming blocked with ice. Additionally, the vessel's crew was unaware that the aft peak, double bottom ballast tanks and No. 4 cargo hold could be used to supply water for short-term emergency cooling.

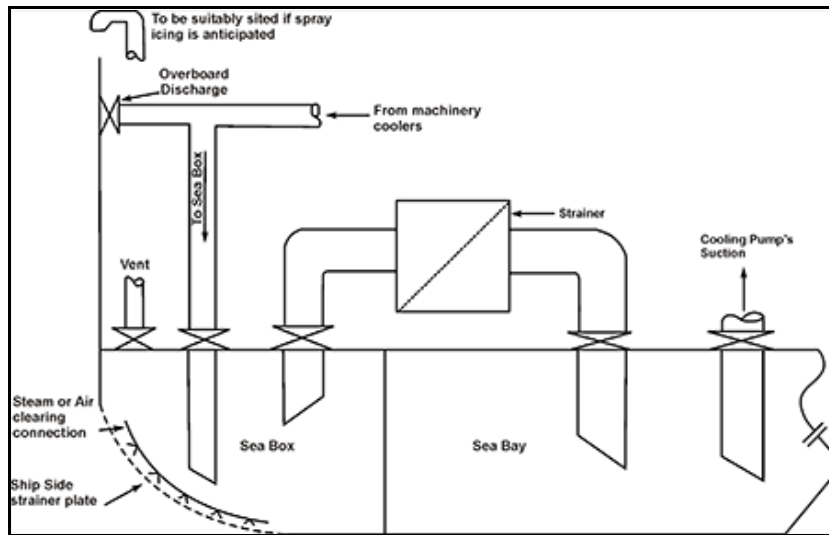
Figure 3. IMO suggested arrangement (port side view, starboard side similar)

Additionally, to raise awareness of the issue, TC's Quebec Region, through a CCG notice, informed ships of the risks associated with ice navigation. The notice was issued before the commencement of 2002–2003 winter season and was to be repeated in subsequent winter navigation seasons. The International Maritime Organization (IMO) recognizes that vessels that do not have an ice class notation are prone to sea suction problems and, as such, are more than likely to be involved in an accident. Consequently, IMO issued Circular 504, *Guidance on Design and Construction of Sea Inlets under Slush Ice Conditions*, in 1989, which provides guidance on the design and construction of sea suction inlets for vessels that navigate under slush ice conditions (see Figure 3).

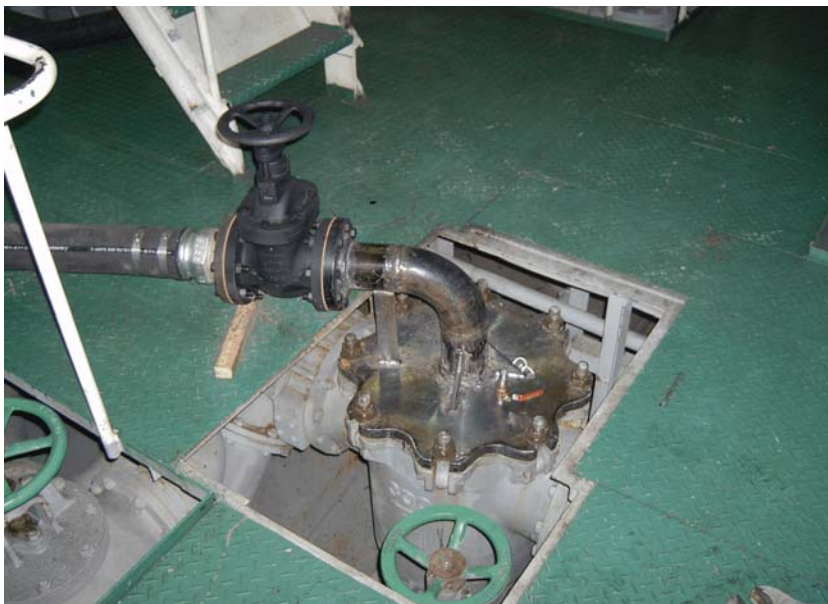
Photo 4. Temporary pipe connected to sea strainer returning main engine cooling water directly to sea chest.

TC required the master of the *Great Century* to obtain proper winter clothing for the crew to work outside. The company was also required to install a temporary pipe connection to the sea water cooling outlet and the strainer of the high sea suction inlet. The latter installation allows water to return to the sea chest instead of the suction end of the main engine sea water pump (see Photo 4).
